Debris/Ice/TPS Assessment and Integrated Photographic Analysis of Shuttle Mission STS-78

*Gregory N. Katnik
Process Engineering/Mechanical System Division/ET-SRB Branch,
Kennedy Space Center, Florida*

**DEBRIS/ICE/TPS ASSESSMENT
AND
INTEGRATED PHOTOGRAPHIC ANALYSIS
OF
SHUTTLE MISSION STS-78**

20 June 1996

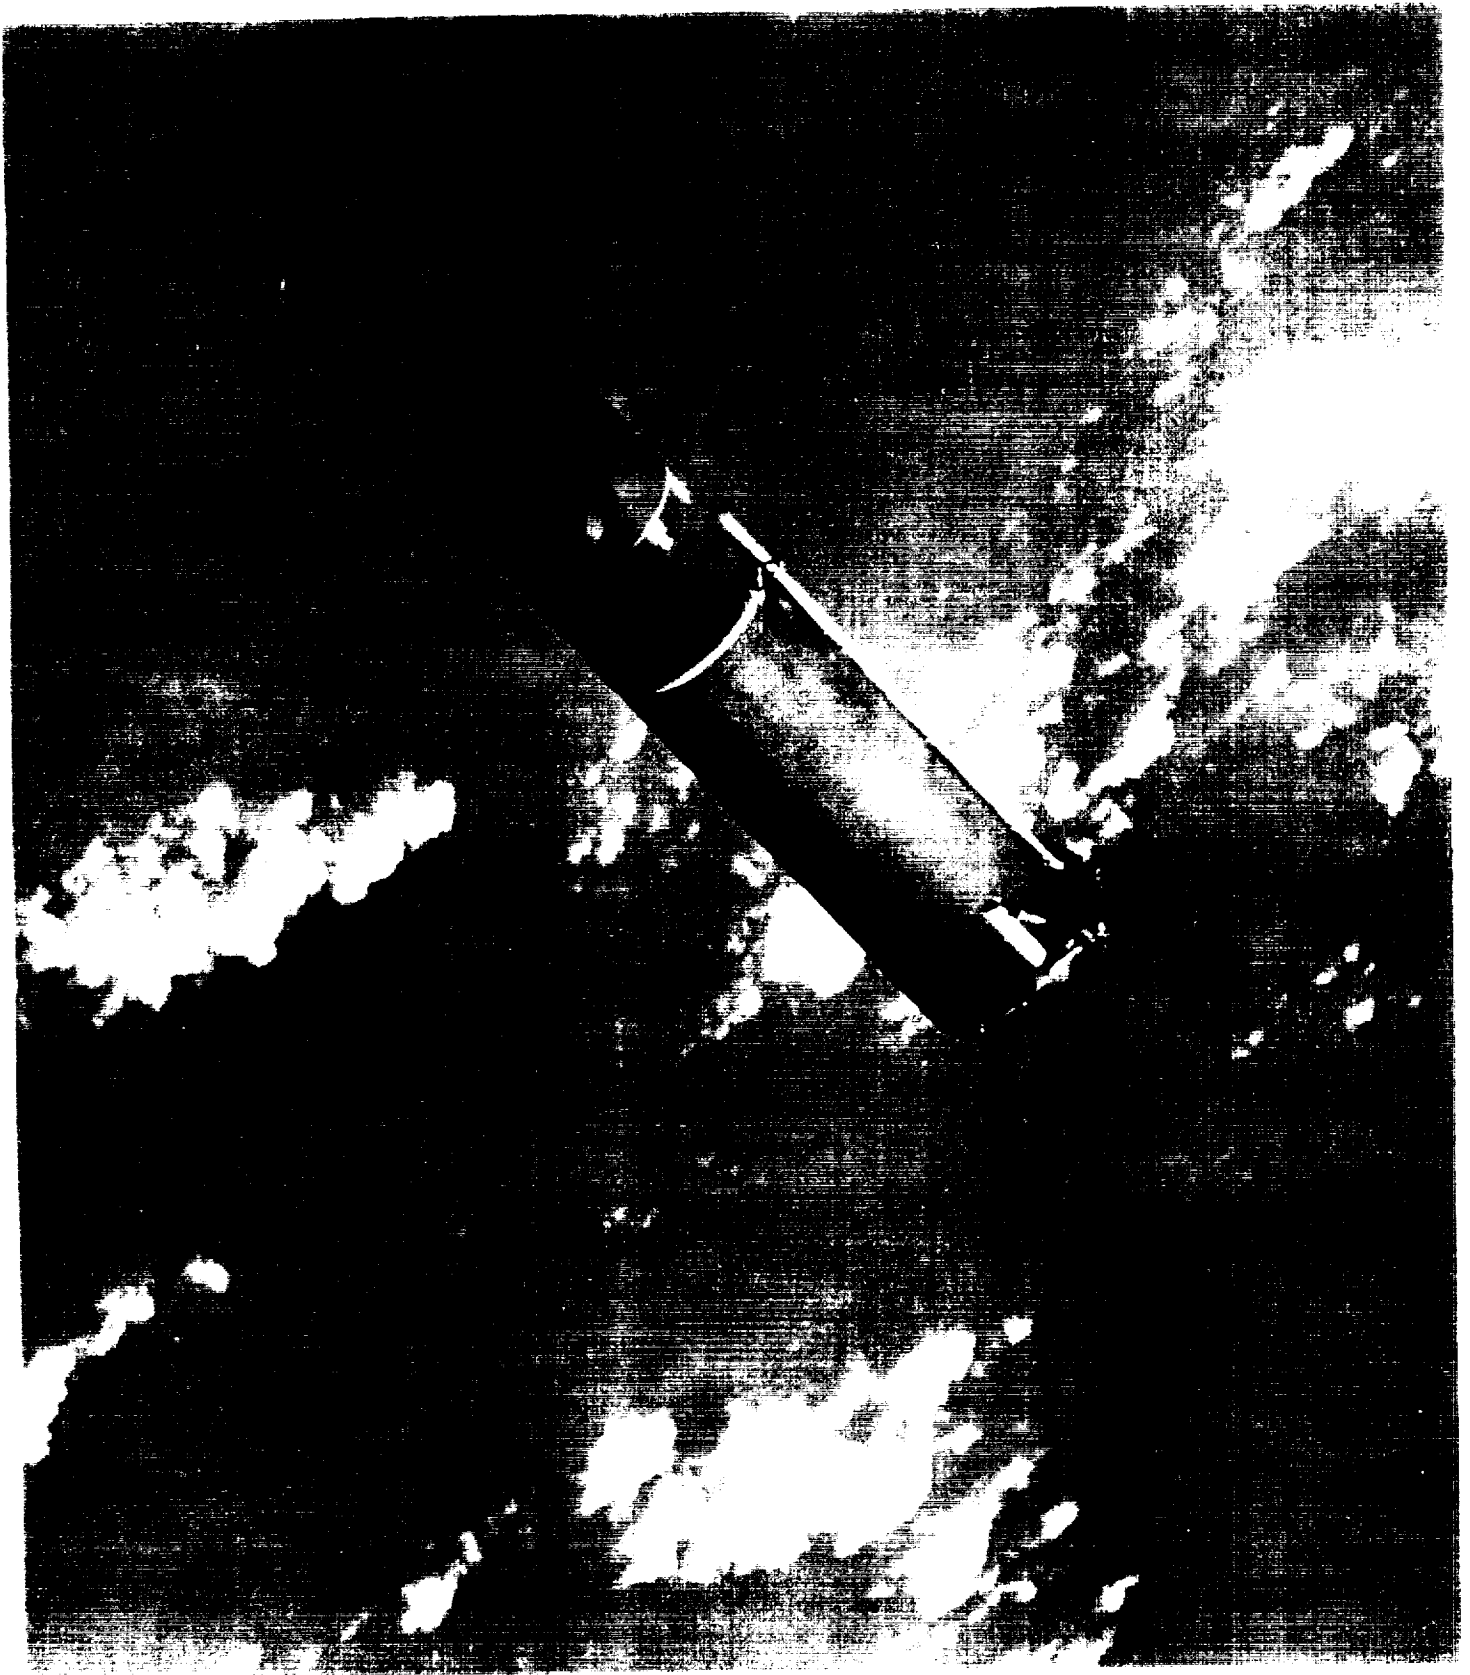
Photo 12: ET After Separation

ET-79 separation from the Orbiter appeared nominal. No anomalies were detected in the LO2 tank, intertank, and LH2 tank acreage CPR. The BSM burn scar on the LO2 tank barrel section was typical

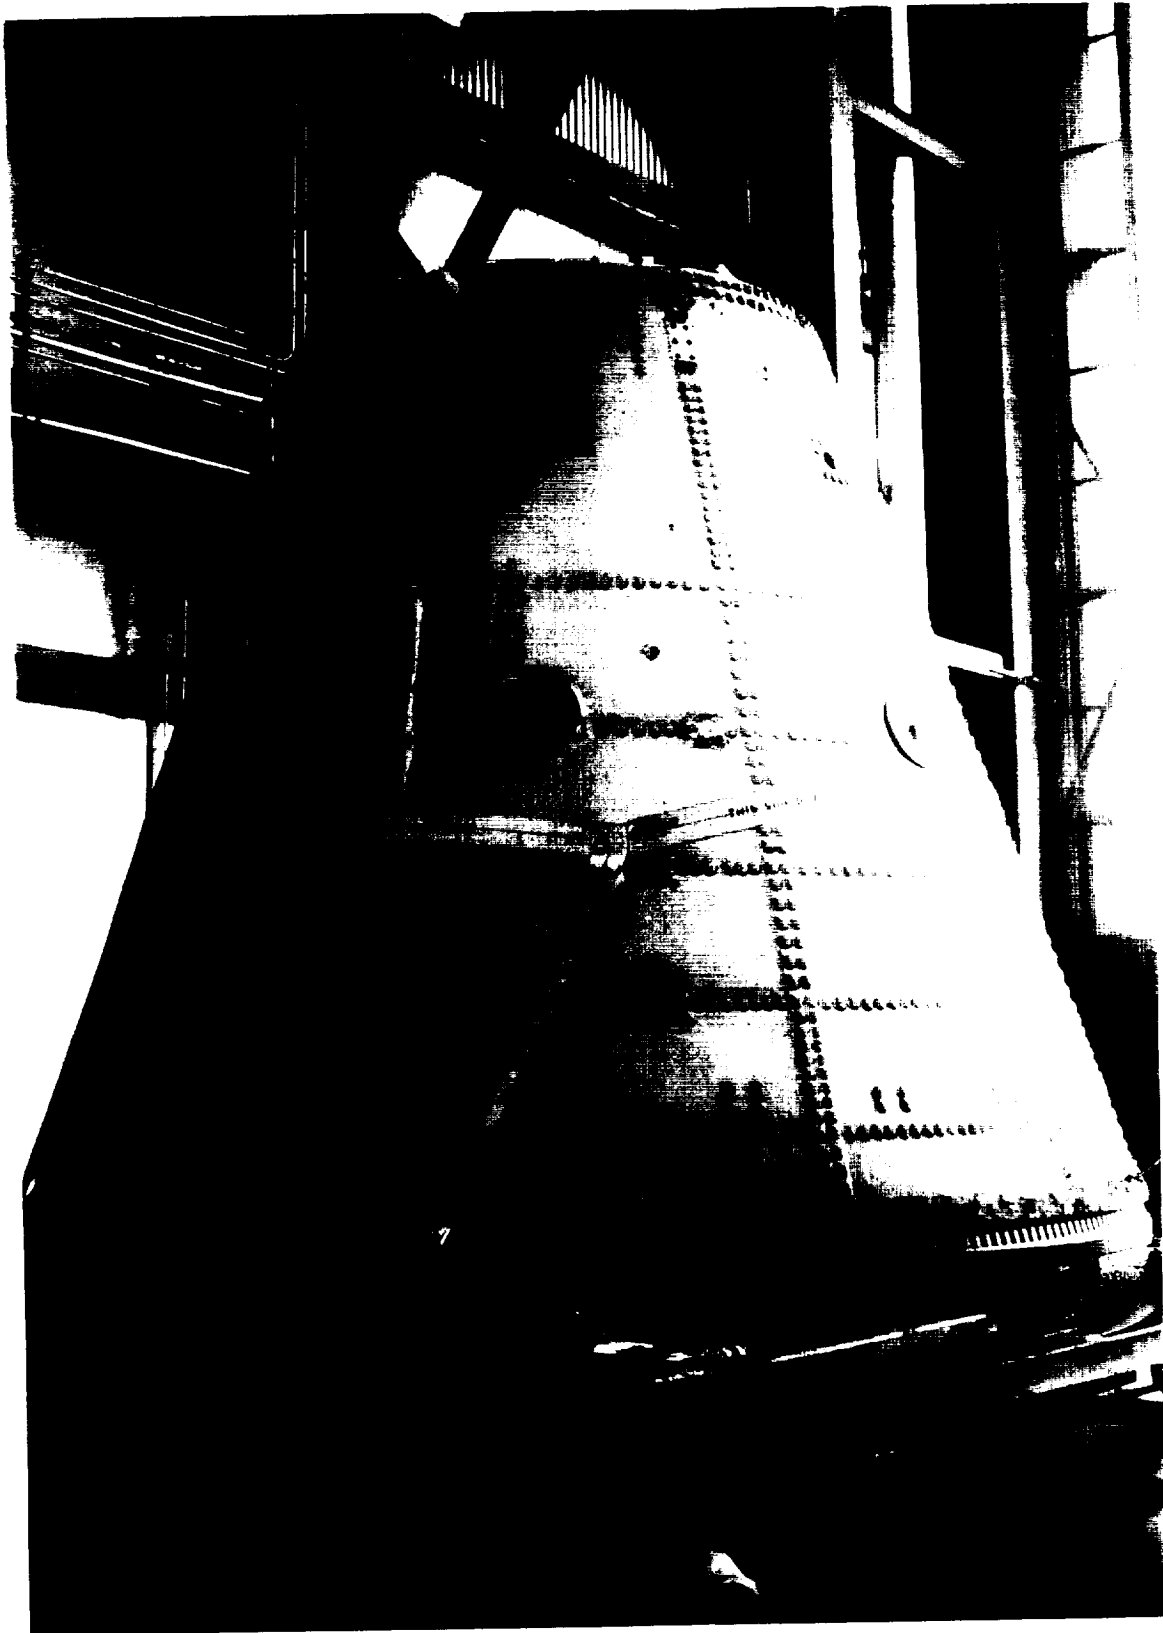
Photo 13: RH Frustum

The RH frustum was missing no TPS. The number of debonds over fasteners (25) was less than average. Hypalon paint was blistered/missing along the XB-395 ring frame where BTA closeouts had been applied. However, most of the exposed BTA substrate was not sooted. The BSM aero heat shield covers had locked in the fully opened position.

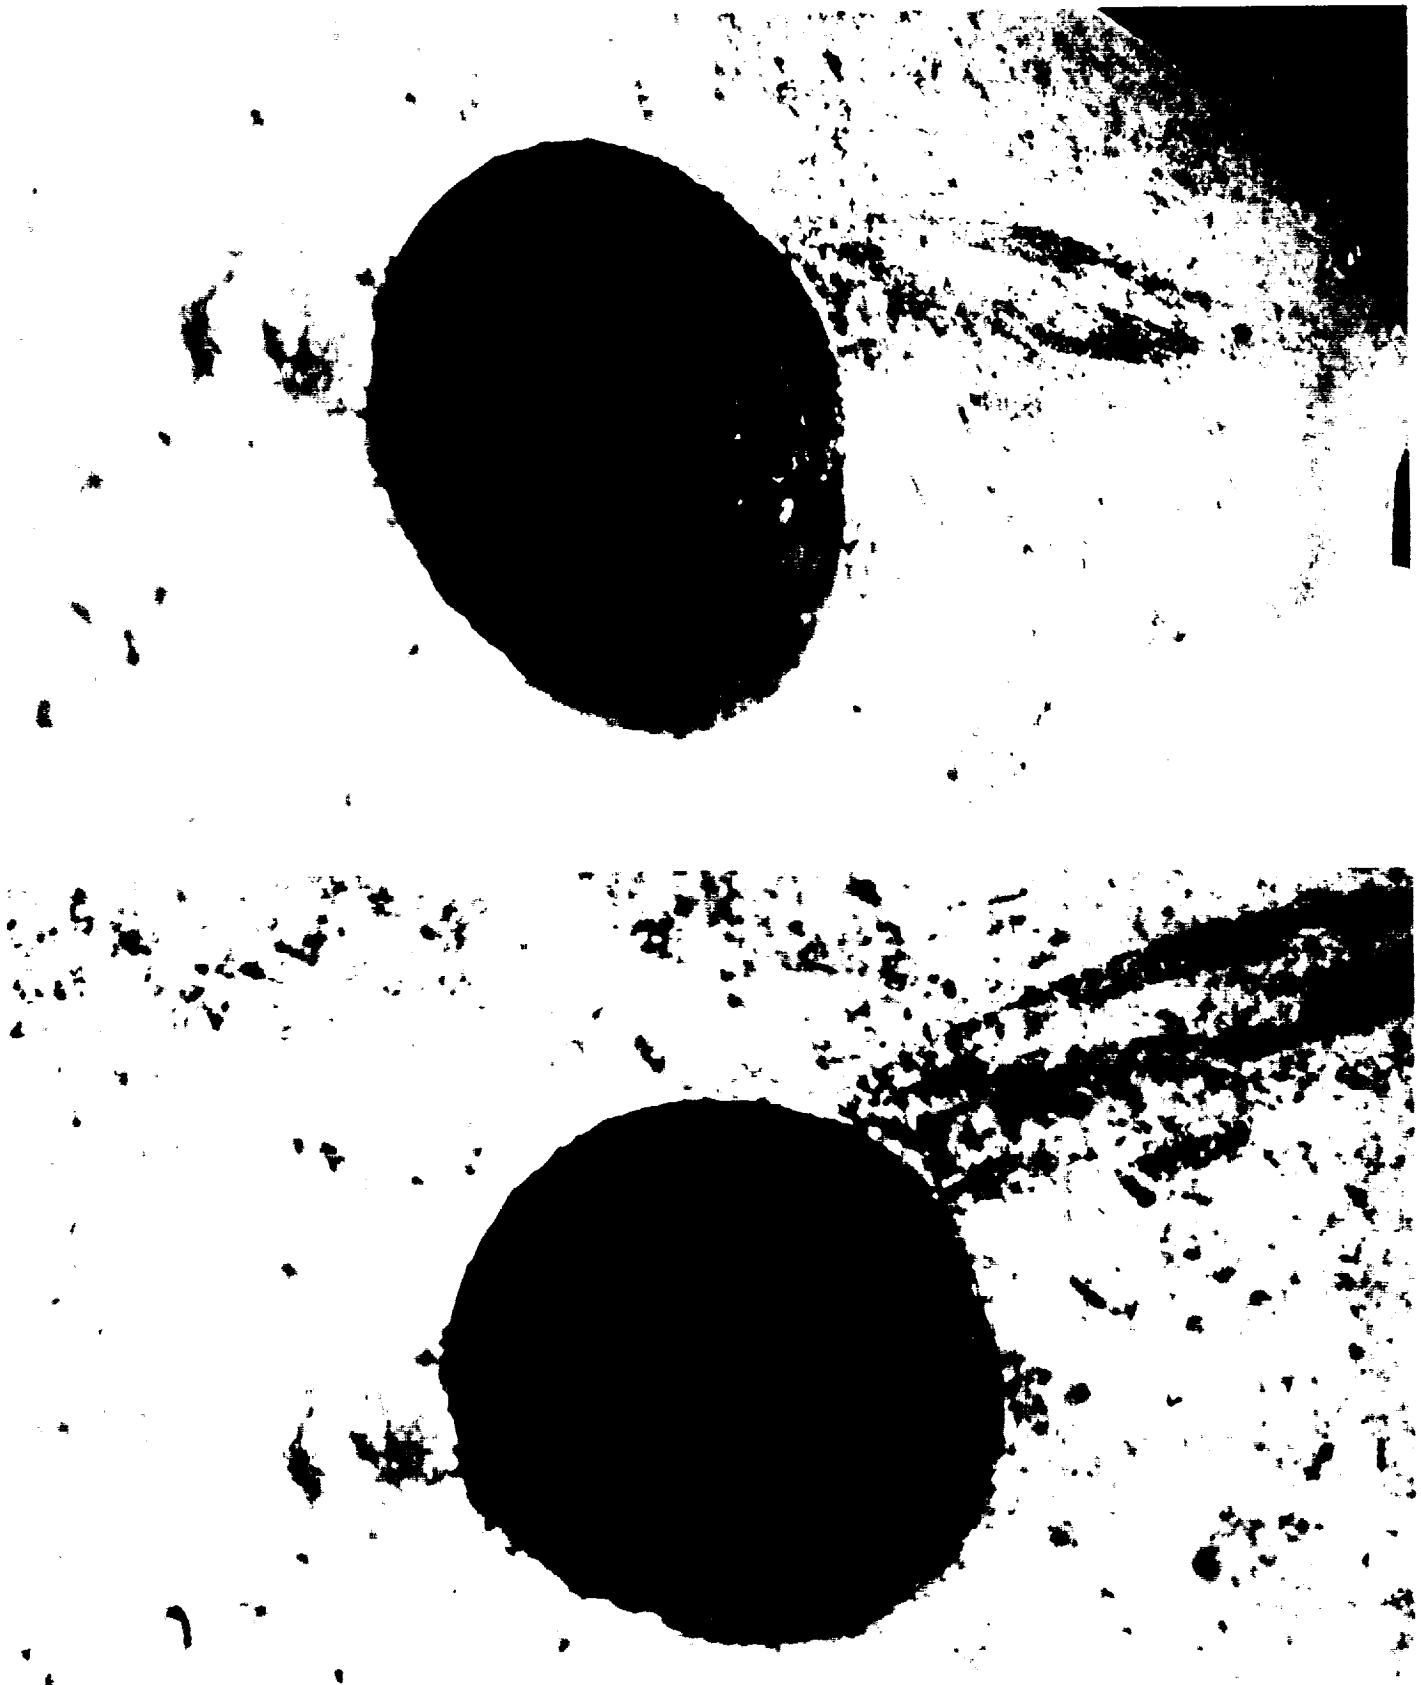
Photo 21: HDP #5 Stud Hole Broaching

A stud hang-up occurred on HDP #5 and the stud hole was broached. Stud impressions were visible in the stud hole wall (arrow). The stud hang-up was confirmed in the launch film review. The HDP DCS plunger, which was seated, pinched an orange seal from the plunger assembly.

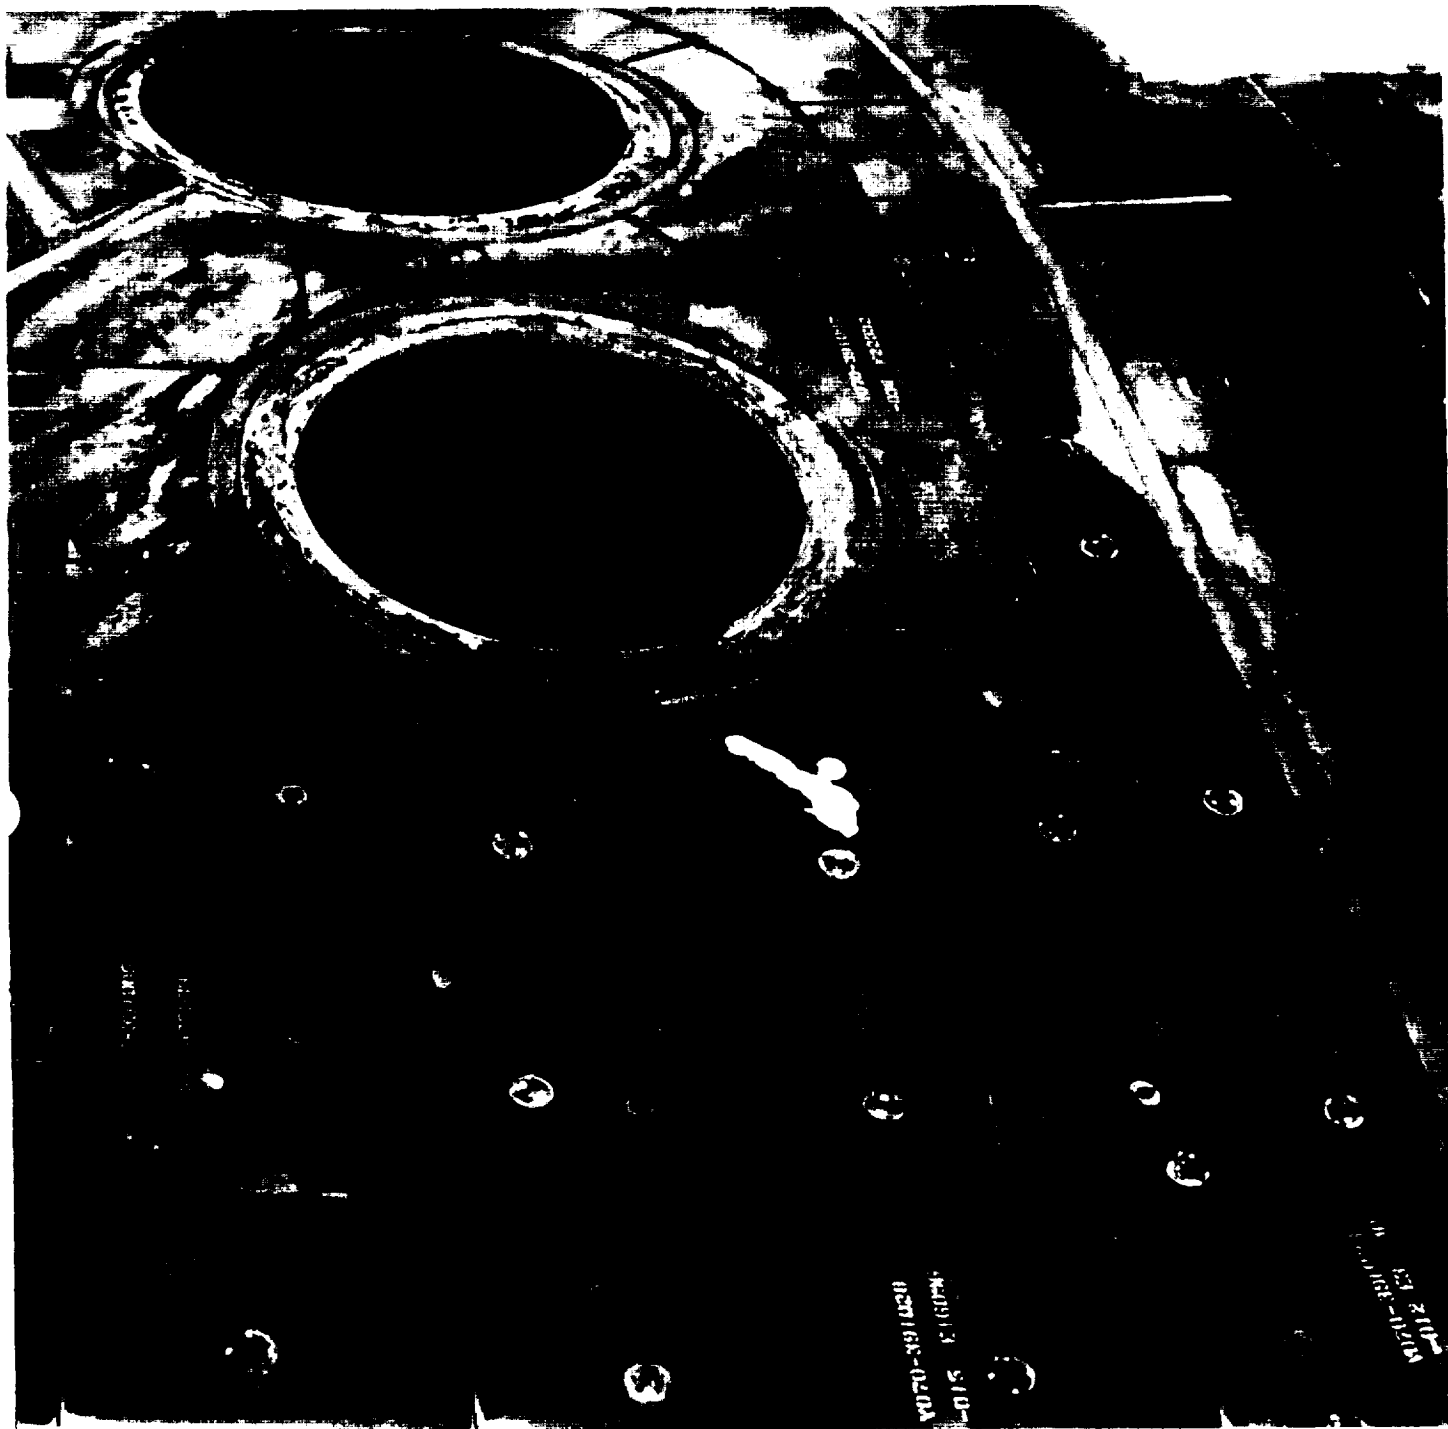
Photo 26: FRCS Tile Damage

Tile damage site measuring 3 x 1 x 0.25 inches was located near the F3L thruster

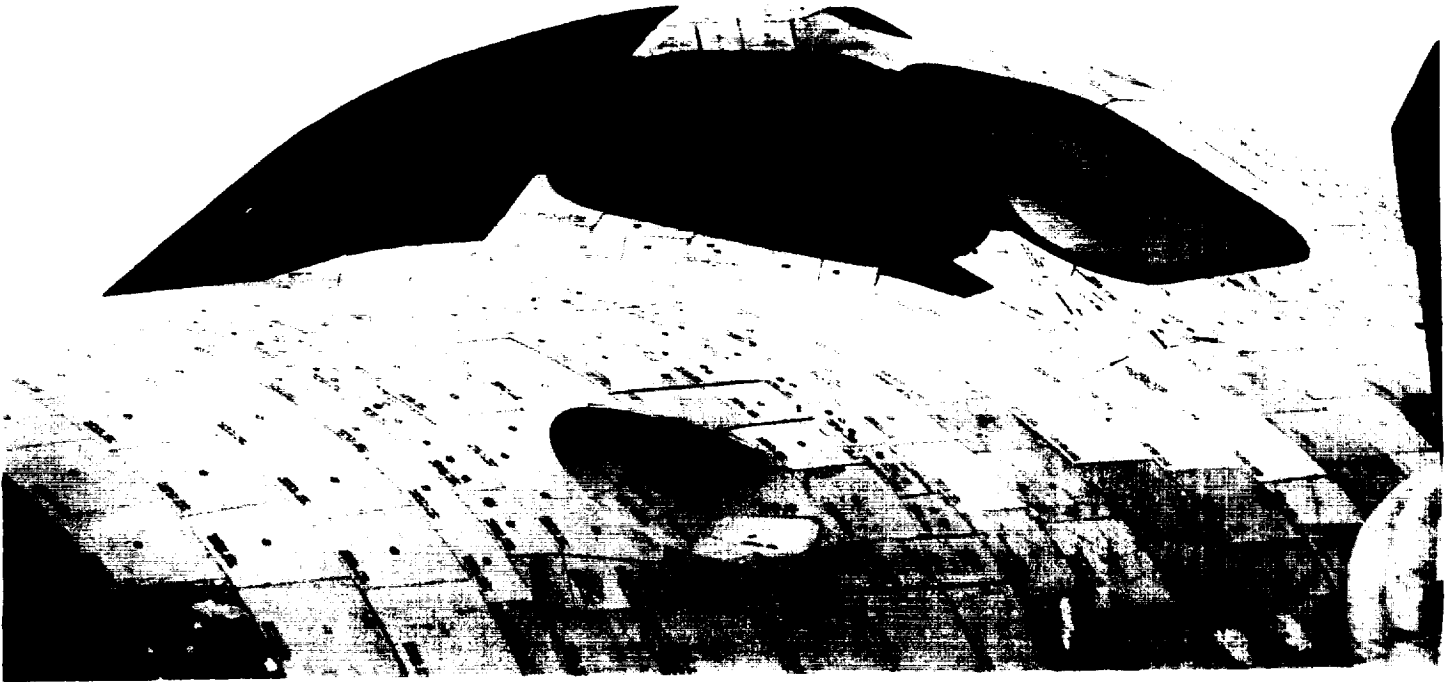
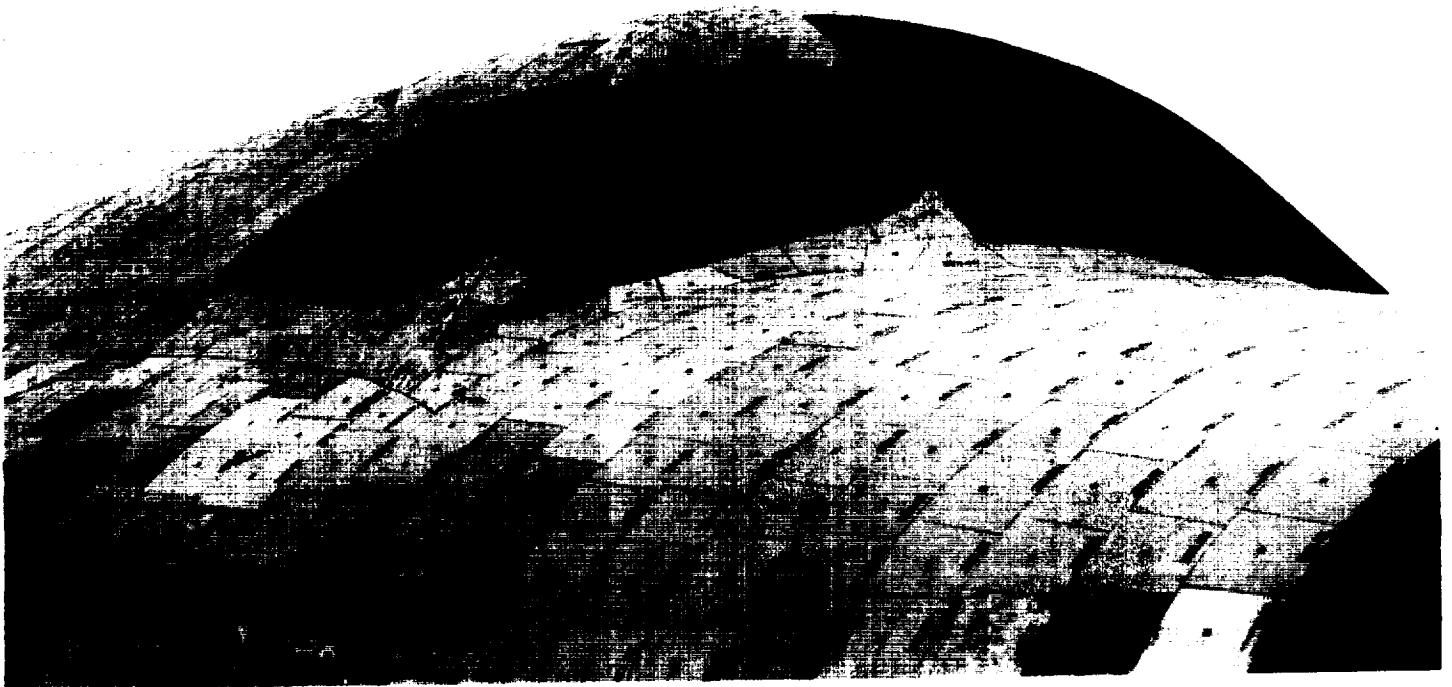
Photo 29: Orbiter Windows

Hazing and streaking of Orbiter windows #2, #3, and #4 was typical. Damage sites on the window perimeter tiles (five hits on window #2; five hits on #3; and four hits on #4) were determined to be new hits. Numerous other damage sites were attributed to old repair material flaking off. A tile between windows #3 and #4 exhibited a damage site 2 x 1 x 0.125-inches deep.

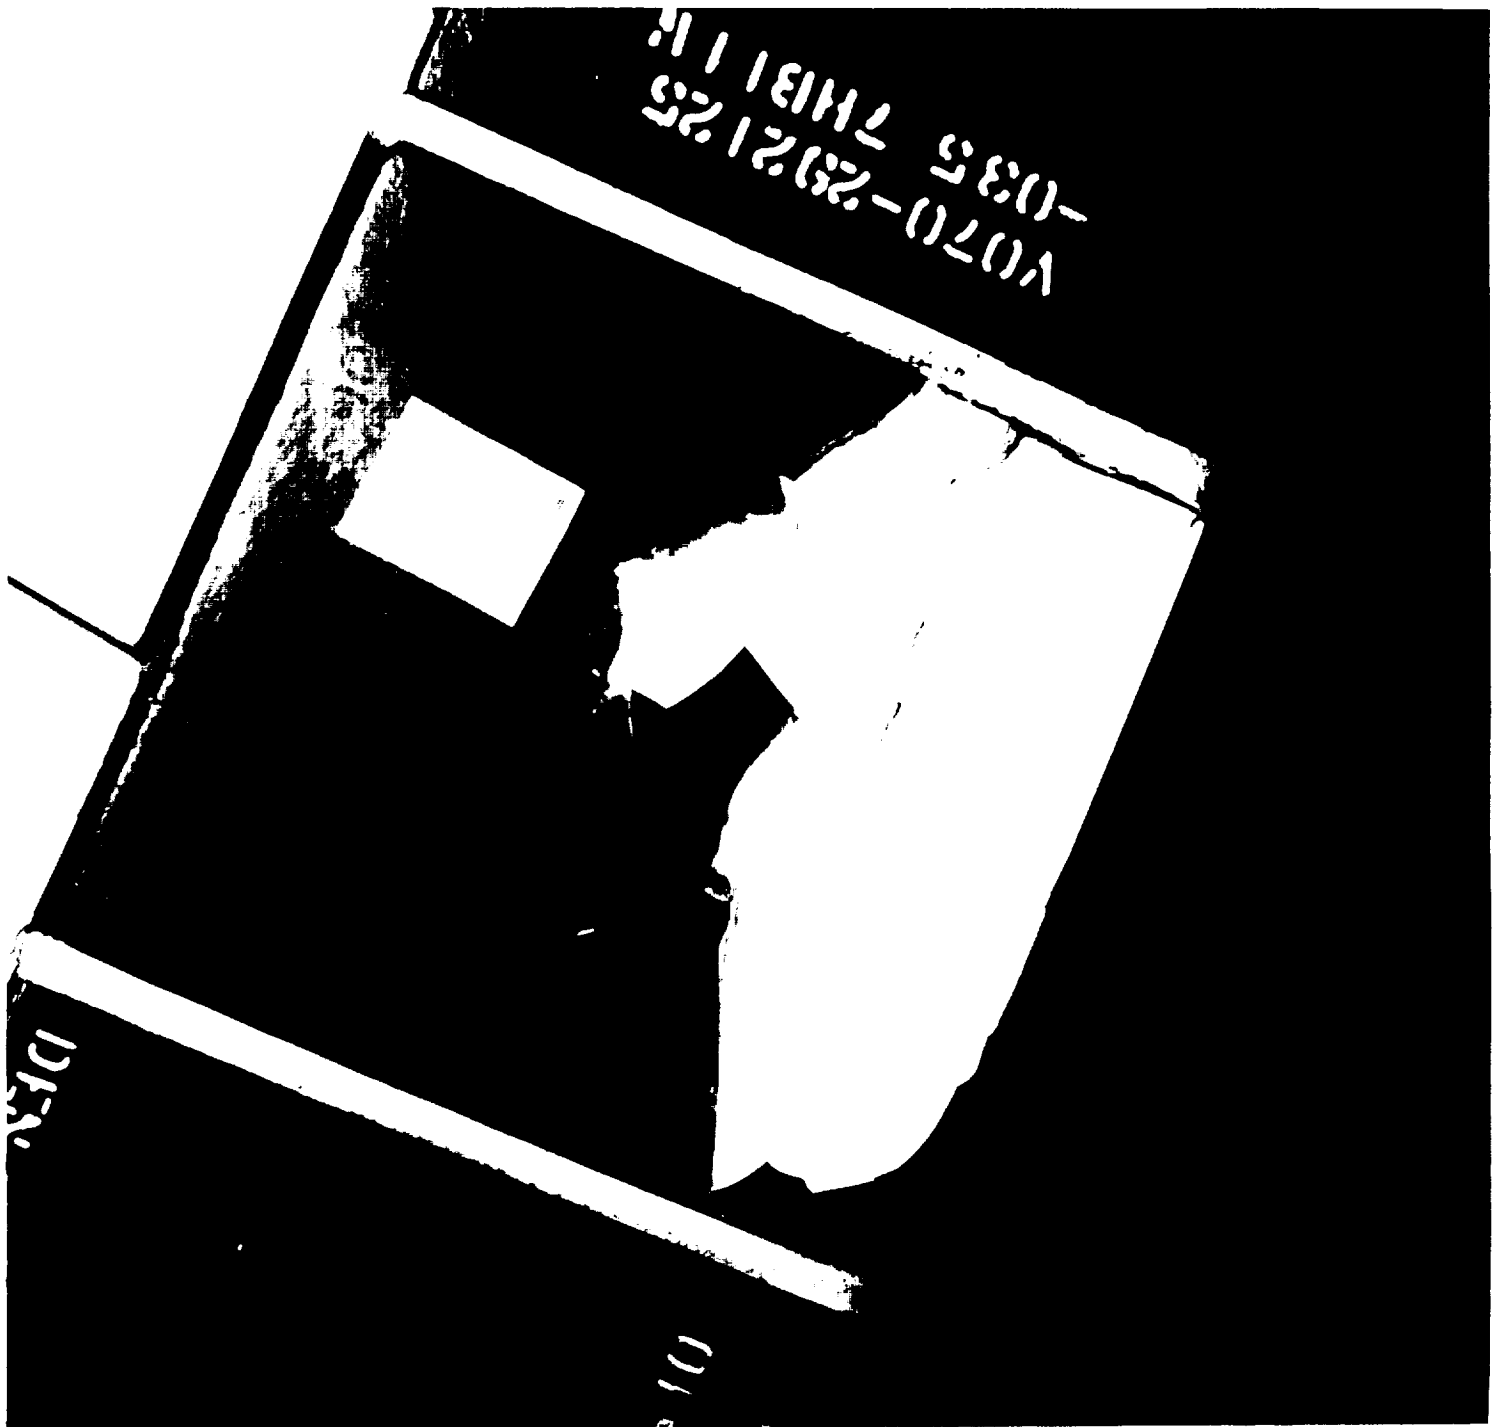
Photo 30: Damaged Tile on Rudder/Speed Brake

Damage to approximately half of one tile on the trailing edge of the left rudder/speed brake did not appear related to drag chute deployment. A previous repair to that tile most likely shook loose during SSME ignition and ascent

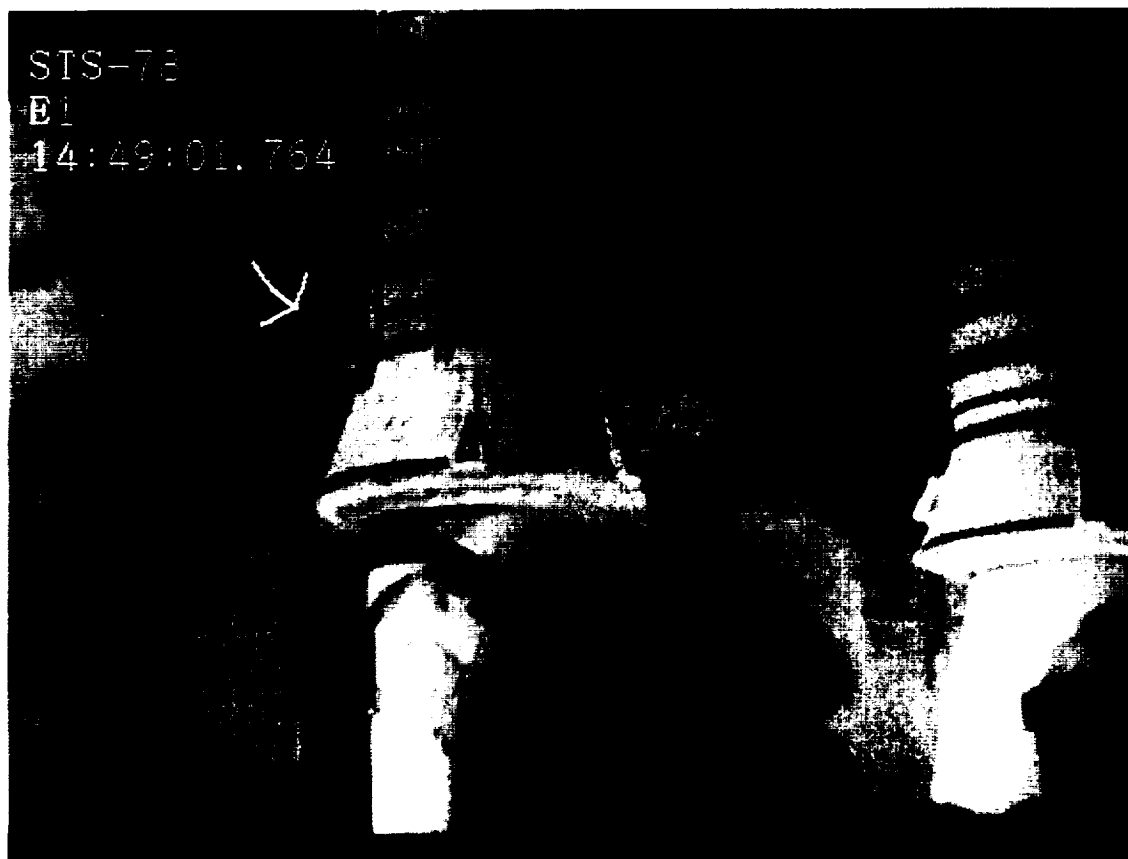
Figure 2.1.2.2 RSRB Flame Duct Debris

Multiple pieces of SRB flame duct debris were seen near the base of the RSRB at liftoff. One relatively large piece appeared to travel close to the Orbiter body flap (14:49:00.593 UTC). A linear shaped, dark colored, flexible piece of debris traveled from the RSRB flame duct toward the Orbiter left wing before disappearing behind the left TSM. None of the debris was seen to contact the vehicle. No follow-up action was requested.

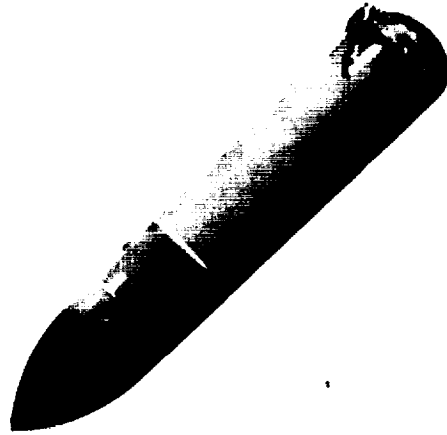
Figure 2.4.2 (A) Handheld View of the External Tank

The first picture was taken approximately 14.3 minutes after liftoff (15:03:17 UTC). All aspects of the external tank were imaged. The external tank appeared to be in good condition on the handheld views.
